Dillingham Bank Stabilization, Alaska

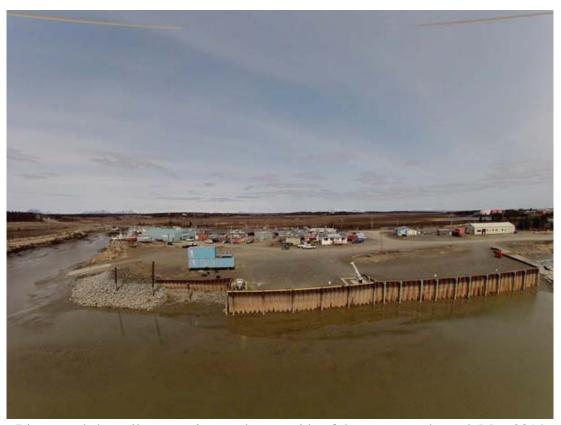
Riprap and sheetpile protection on the east side of the entrance channel, May 2014

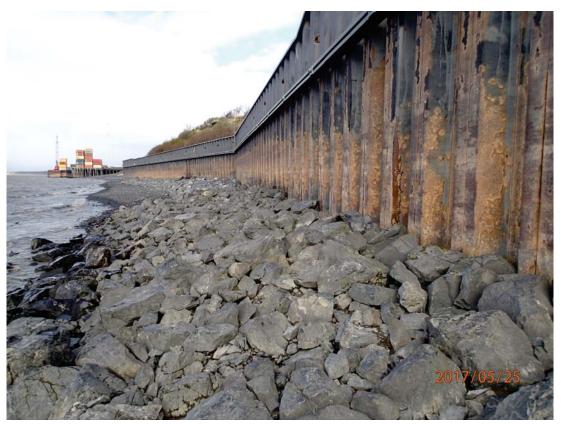
STA 21+00, Riprap @ Toe, Facing Downstream, May 2017

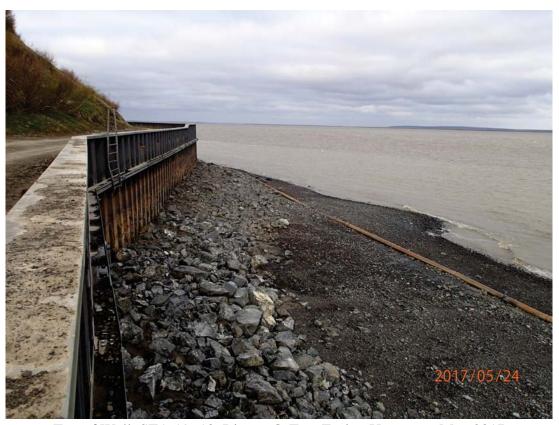
Top of Wall, STA 19+10, Riprap @ Toe, Facing Upstream, May 2017

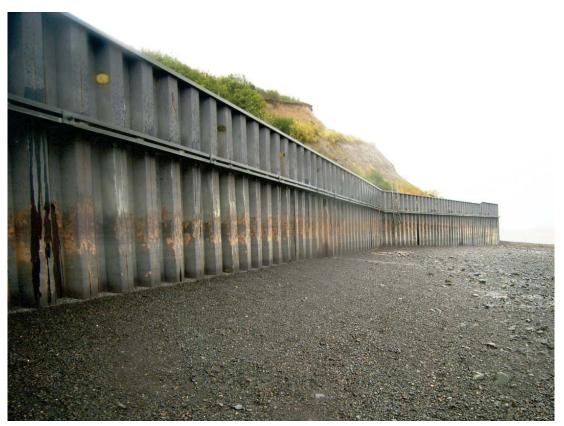
H-pile supported sheetpile bulkhead, September 2008

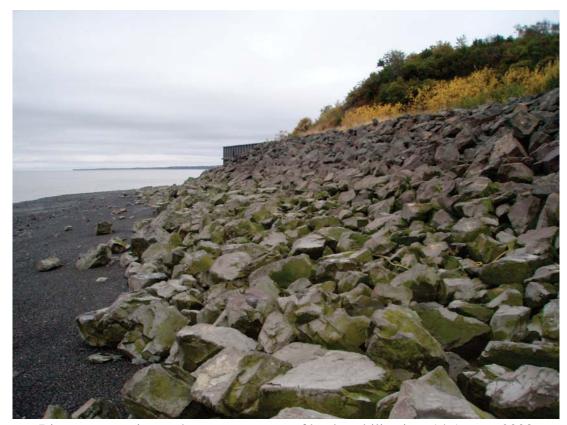
Rip-rap protection at the eastern extent of bank stabilization, 14 August 2008
