Geotechnical Report

December 31, 2019

GEOTECHNICAL RECONNAISSANCE FINDINGS AND PRELIMINARY ENGINERING CONSIDERATIONS, WASTEWATER LAGOON SITES, DILLINGHAM, ALASKA

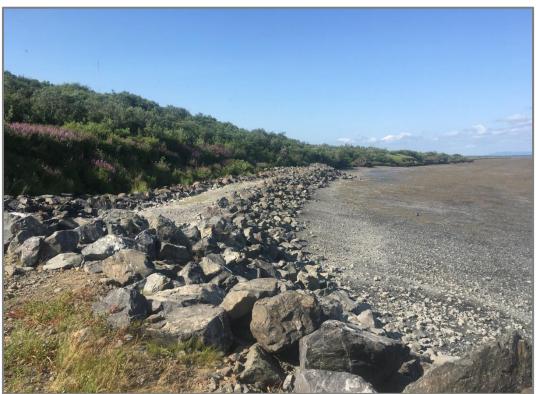
Coastal erosion mitigation measures include a sheet pile wall and armor rock installed along the shoreline within 700 to 800 feet (approximately) south of the lagoons. The zone with coastal protection measures appeared to reduce and possibly stabilize the progressive shoreline loss relative to unprotected areas northward along the shoreline.

Existing Lagoon Site, General Beachline Conditions and Locally Available Armor Rock, View NE

The existing wastewater treatment site appears to have adequate area for facility expansion using a similar mass excavation earthwork approach used for the current lagoons. However, shoreline protection is advised to control coastal erosion risks for extended use of this site. There are at least two rock quarries in the general area that may be able to produce riprap for shoreline armour material. Additional civil, geotechnical and coastal engineering analysis as well as permitting will be required to refine the appropriate armour system for this site. However, left unprotected, continued shoreline regression and erosion should be anticipated with the rate and geometry of additional shoreline loss requiring additional coastal process assessment and engineering evaluation.

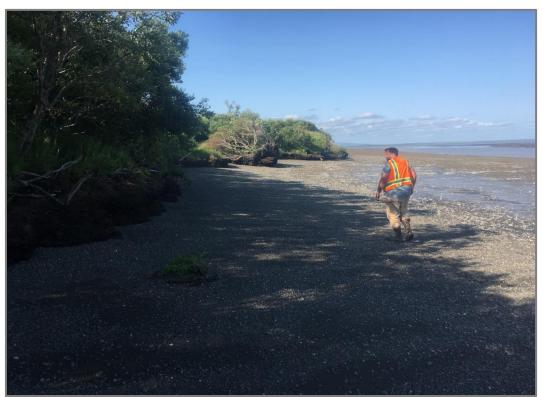
Bluff exposures along the unprotected shoreline roughly normal to the wastewater treatment cells indicated a several foot thick organic mat overlying silts with varying organic contents. Sloughing and slope instability along the unprotected area is prevalent.

Existing Lagoon Site, Beachline Conditions Showing Organic Mat Along Unarmoured Facing, View NE

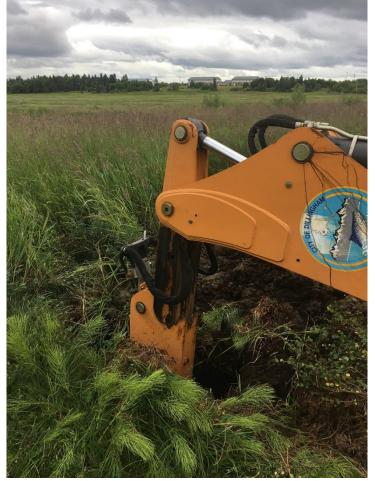
One shallow test pit was advanced by the city along the western margin of their fill pad. The test pit was advanced with a Case 580 rubber-tired backhoe. The general subsurface conditions encountered in this test pit are summarized below.

Site 2 Test Pit adjacent to City Shop fill pad

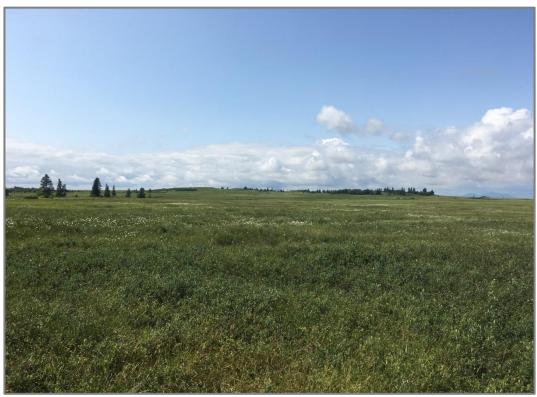
Site 3 is a large tract that borders Kanakanak Road and extends westerly for approximately one mile. A series of topographic rises are present along the western margin of the tract. The majority of the area is mostly grass vegetation with defined surface drainages along the margins of the areas. Some standing water was present along Site 3 near the roadway with the majority of the site not accessed. A series of timber power poles borders the southern margin of the site. The power poles appeared to be direct site vertical with minimal leaning or other deflections.

Site 3 General View from Roadway, view west
