Geotechnical Report

December 31, 2019

GEOTECHNICAL RECONNAISSANCE FINDINGS AND PRELIMINARY ENGINERING CONSIDERATIONS, WASTEWATER LAGOON SITES, DILLINGHAM, ALASKA

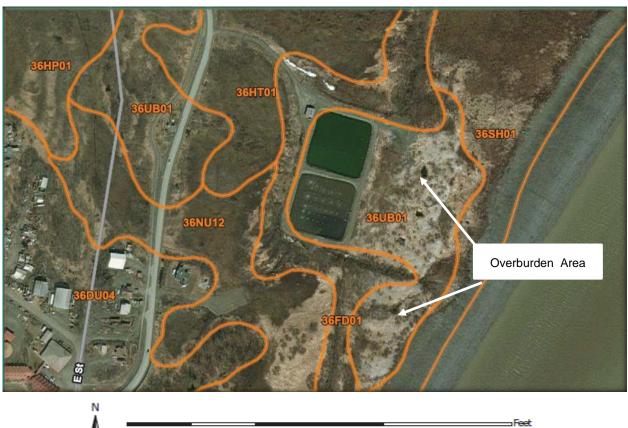
Existing Lagoon Site, Beachline Conditions Showing Organic Mat Along Unarmoured Facing, View NE

The exposed slope adjacent to the existing lagoons are classified by the NRCS as Flounder highly organic silt loam with increasing gravel content with depth (approximate 6 feet below undisturbed grade. It is reasonable to assume the existing lagoons were developed in the higher gravel content mineral soils. If so, these materials should be suitable for shallow foundation load bearing. The existing lagoons appear to be geotechnically stable with no visual indications of significant slope instability.

The existing wastewater treatment site appears to have adequate area for facility expansion using a similar mass excavation earthwork approach used for the current lagoons. However, shoreline protection is advised to control coastal erosion risks for extended use of this site. There are at least two rock quarries in the general area that may be able to produce riprap for shoreline armour material. Additional civil, geotechnical and coastal engineering analysis as well as permitting will be required to refine the appropriate armour system for this site. However, left unprotected, continued shoreline regression and erosion should be anticipated with the rate and geometry of additional shoreline loss requiring additional coastal process assessment and engineering evaluation.

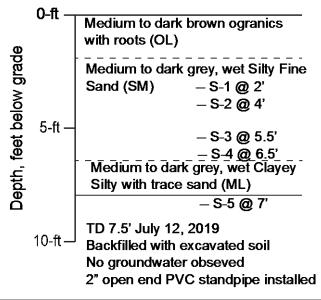
Site 2 Test Pit adjacent to City Shop fill pad

Dillingham Lagoons Geotechnical Test Pit Log Test Pit: TP-1, Logged by Golder Date: July 12, 2019 Case 580 Backhoe

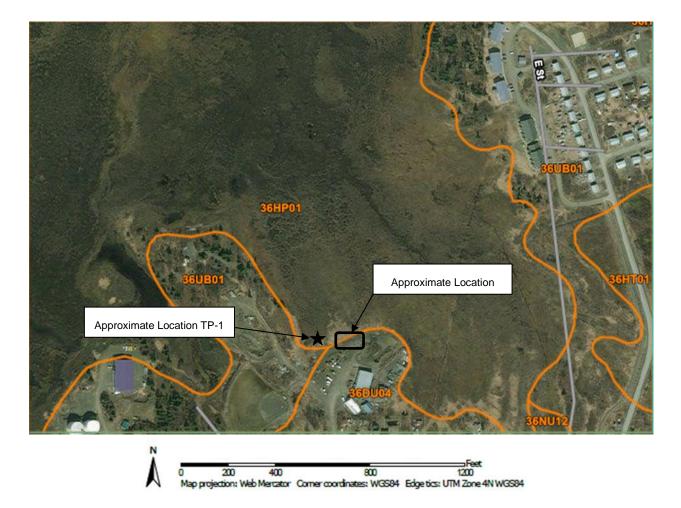
The US Department of Agriculture, Natural Resources Conservation Service (NRCS) mapped the soils to approximately 6 feet below grade. In the grassland area for this site, the NRCS soil classification was predominately the Wearyriver Peat, mostly organics over silty loam. This classification is in general accordance with the shallow test pit findings located at the edge of the City Shop fill pad.

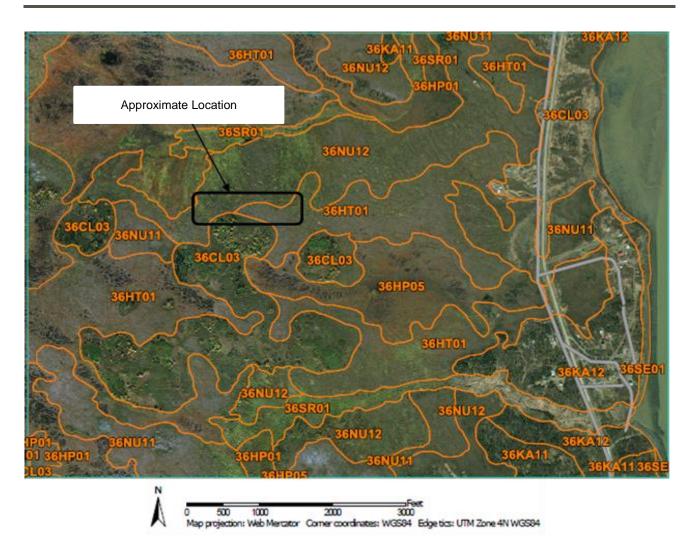
Site 3 General View from Roadway, view west

The NRCS mapped the elevated areas as the Nushagak Clarkspoint Complex, a predominately well-drained silty loam with increasing sand content with depth (to about 6 feet). The lower lying, grassy areas were classified by the NRCS as the Pellernargug Wearyriver Complex and the Pellernargug Mucky Peat. Both classifications infer poorly drained, high organic content soils with some silty loam at depth in some areas. These soil classifications are expected to be in general accord with the glacial depositional environment in the area.
