DILLINGHAM BANK PROTECTION

DILLINGHAM, ALASKA

Dillingham Bank Stabilization

Condition of Improvements
30 December 2015
Dillingham Bank Stabilization, Alaska
(CWIS No. 075441)

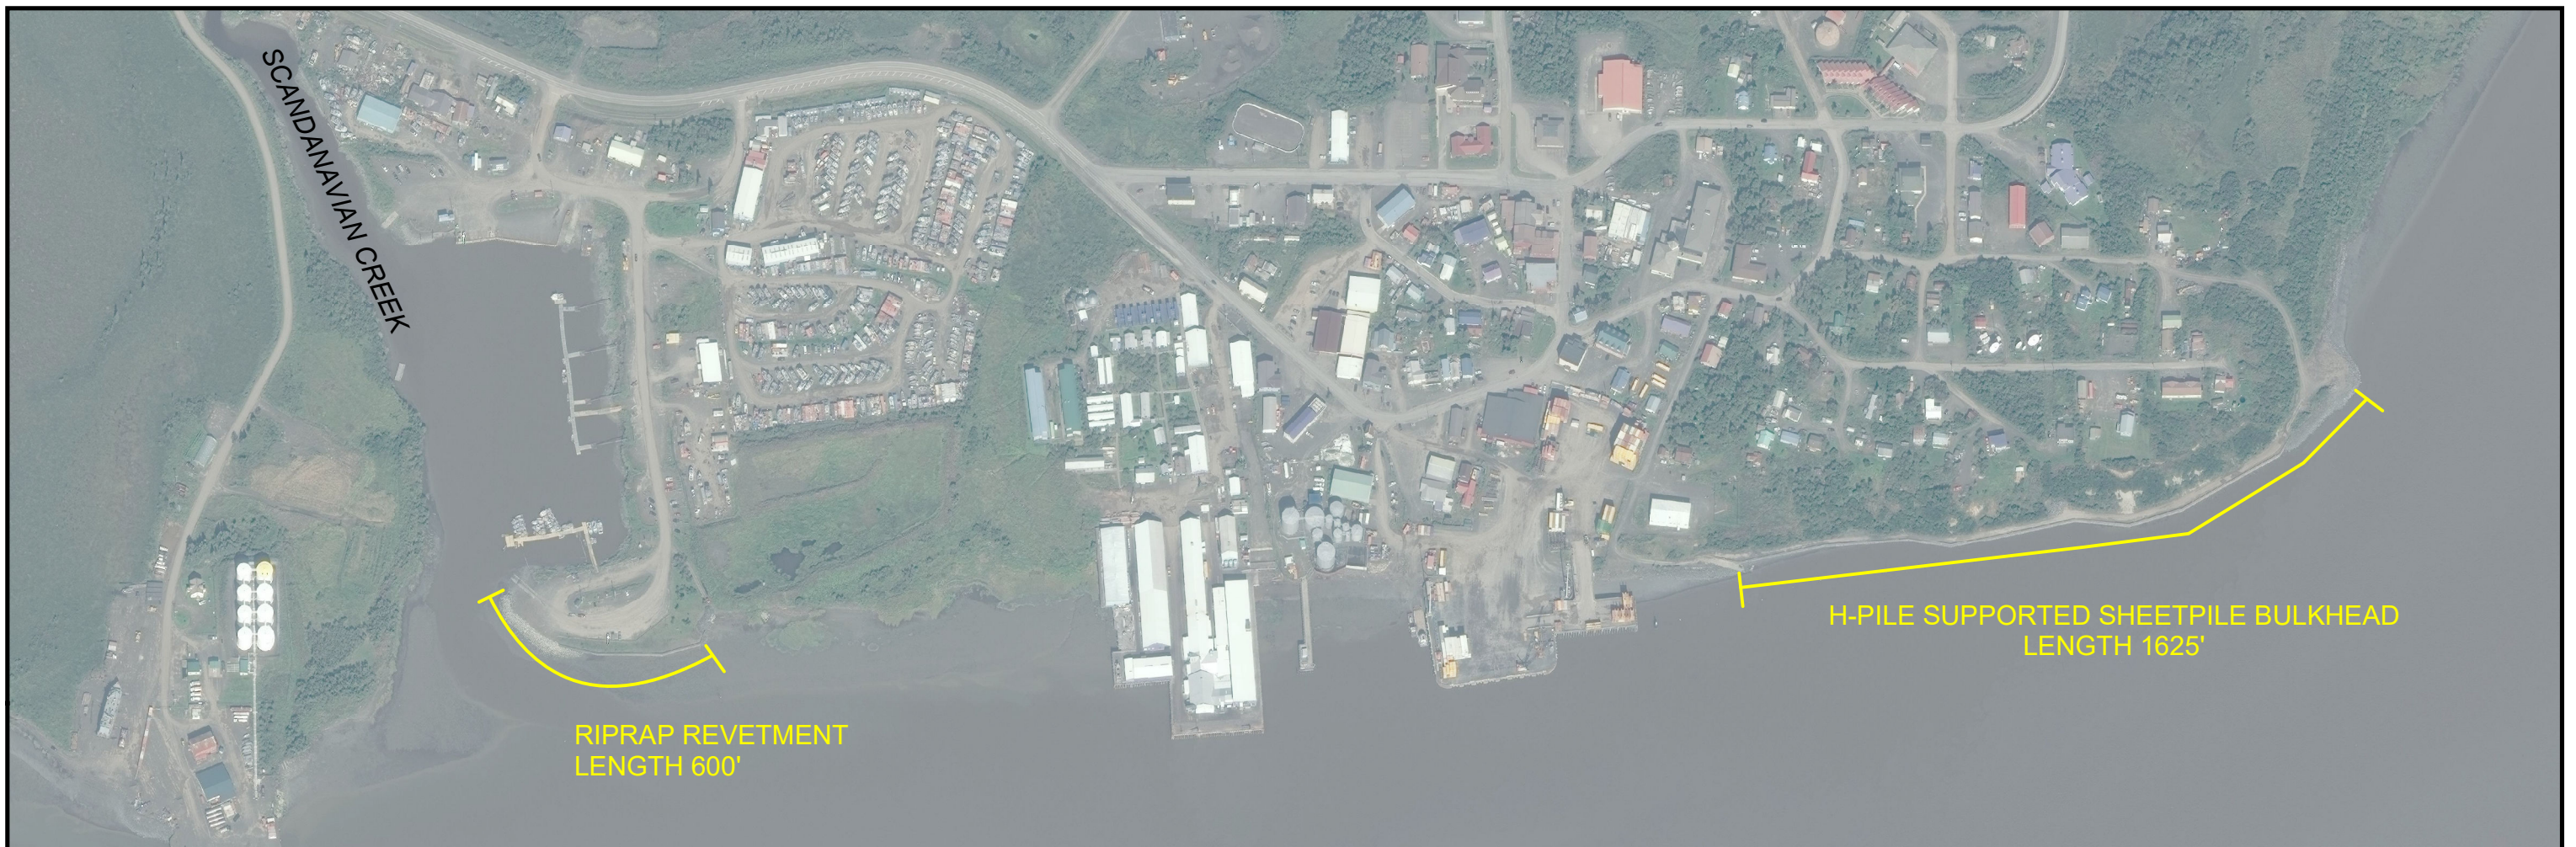
H-PILE SUPPORTED SHEETPILE BULKHEAD
LENGTH 1625'

RIPRAP REVETMENT
LENGTH 600'

NUSHAGAK RIVER

1:5,000

The rock revetment in the alignment shown in Figure 2 would likely have to be placed below the ordinary high water level of the river (approximately mean higher-high water). Construction work below the ordinary high water level is regulated by the US Army Corps of Engineers (USACE) due to the detrimental impacts such activities can have on aquatic life, including salmon. If this is the case, a USACE permit will be required to place the rock. Although the purposes of the project will likely justify a permit, the permit process will extend the project schedule and may require mitigation to offset environmental impacts. The alignment can be adjusted slightly landward to avoid in-water work. However, if rock is placed in an upland location, it will need to be keyed into the substrate to expected erosion depths as described above. This will require excavation of native peat material and replacement with rock. This excavation would greatly expand the project footprint for the rock revetment.
